PORT HOUSTON Maritime Facilities Inspection and Condition Assessment Course Binder

Modules 1-7 and Capstones 1 and 2

Facility Inspection & Condition Assessment Program (FICAP)

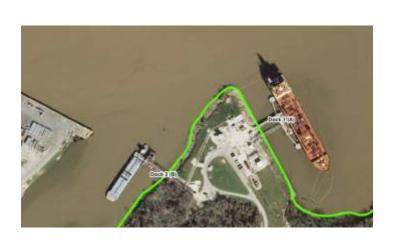
Boat Dock

- Similar to wharves, but self-supporting
- Functional purpose: loading and unloading cargo or personnel from vessels

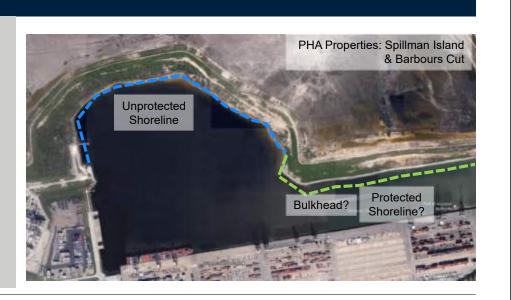
Shoreline

- Intersection between land and water
- May be protected or unprotected

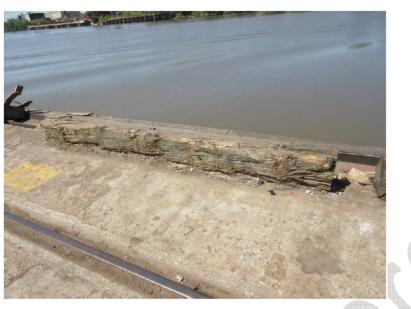
Figure 15. Typical wharf log distress

Figure 15. Typical wharf log distress

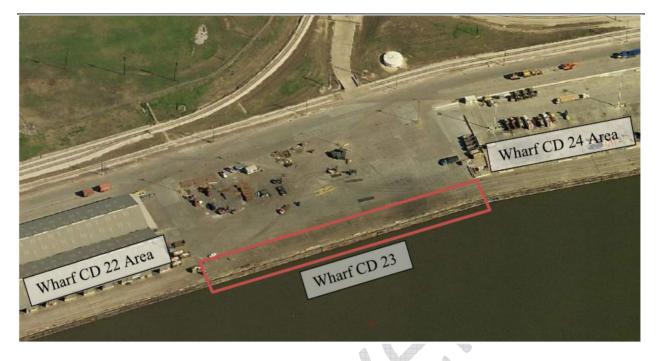
Figure 2. Aerial view of structure and immediate vicinity.

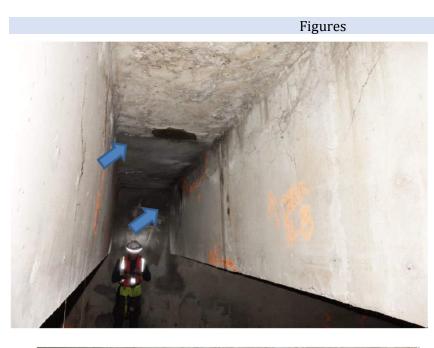
Figure 5. Beam bottom spall and delamination

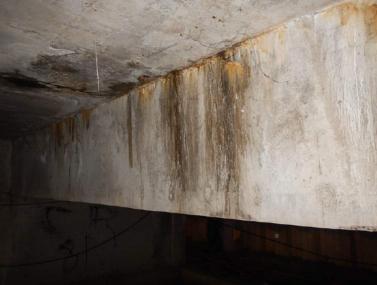
Figure 6. Crack at beam to deck transition

Str	uctural Com	ponent Ratings and Element Summary
Component / Element(s)	Rating	Comments
Deck		Add Narrative:
RC Deck Topside		Overall, approximately 30 percent of the deck topside was identified as delaminated or spalled. The topside of the concrete deck was generally scarred and gouged from mechanical impact, with gouges up to 1 inch deep.
RC Deck Underside		All -five exhibited concrete delamination or spalls. Some of these delaminations were observed to occur randomly within the field of the deck, but most delaminations and spalls were concentrated along deck construction joints, cracks, and penetrations. On average, approximately 7 percent of the deck underside exhibited spalls or delaminations.
Slab		· · · · · · · · · · · · · · · · · · ·
RC Slab		Not inspected
Superstructure		Add Narrative:
RC Deck Beam		Approximately 25% of the beams were in good condition, and about 75% of the deck beams were rated as fair condition. The distress in these beams mainly consisted of random small spalls and delaminations on the vertical or bottom faces of the beam (Figure 5). Most beams exhibited a horizontal crack along the top of the beam near the beam-to-deck transition (Figure 6), and some exhibited shear cracking (Figure 7).

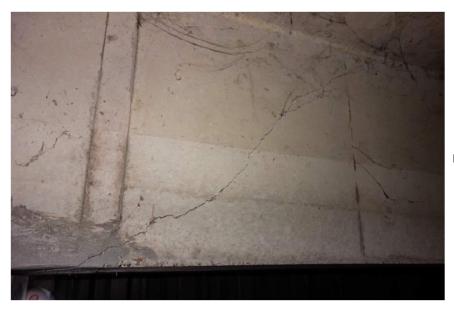
Figure 7. Deck beam shear crack

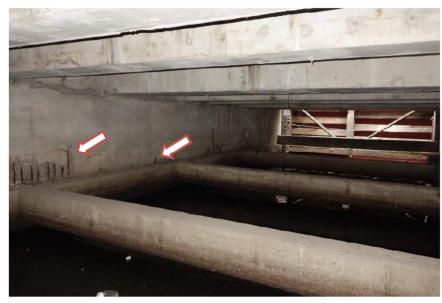
Figure 10. Spalling at RC Shear Wall

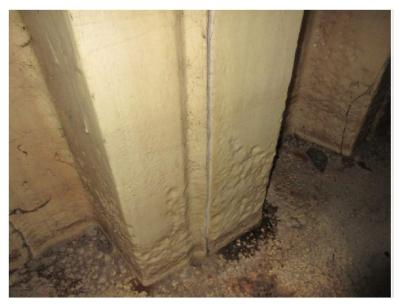
Figure 12. Pitted Sheet Pile Wall

Structural Component Ratings and Element Summary (continued)			
Component / Element(s)	Rating	Comments	
Bulkhead		Add Narrative:	
CS Bulkhead Wall		Evidence of previous moderate to severe pitting of the sheet	
		piling was generally visible in the bottom 12 inches of the exposed portion of sheet piles above wale beam (Figure 12).	
		Section loss is generally minor to moderate (fair condition).	
RC Bulkhead Wall		Not inspected	
RC Bulkhead Pile Cap		Not inspected	
CS Bulkhead Wale Beam		The concrete encasement for the tieback whaler along the bulkhead wall exhibited minor surface spalls and delamination along the top edge at some locations, as shown in Figure 13.	
CS Bulkhead Tie Rod		Fair condition along entire length. Not inspected	
В	erthing Comp	oonent Ratings and Element Summary	
Component / Element(s)	Rating	Comments	
Fender System		Add Narrative:	
CS Fender Pile		Isolated moderate to severe corrosion of fender piles within

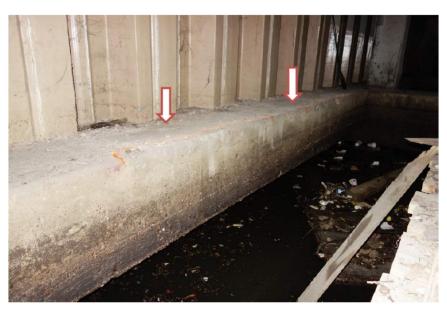
Figure 13. Delamination on tieback whaler

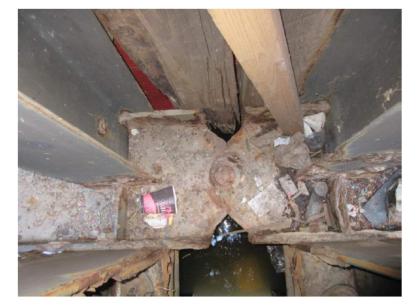
Figure 14. Bent 11 secondary framing pinned connection

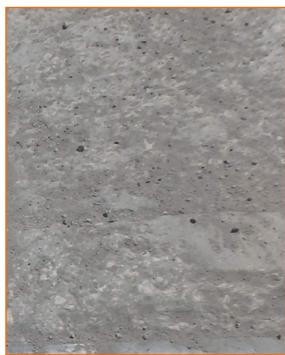
Raveled deck surface; course aggregate still secure; photo # 747-005

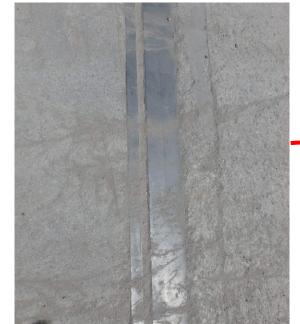
Expansion joint; no alignment or adhesion issues observed; photo # 747-003

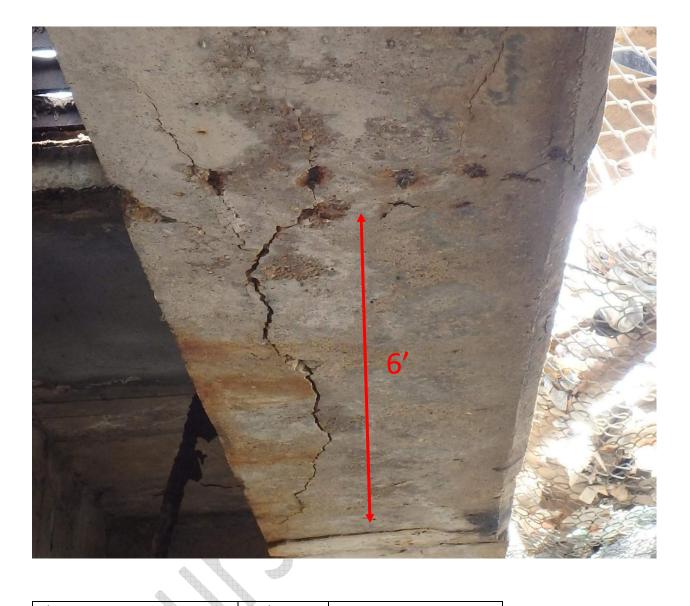
Element ID	Photo #	Notes
DU24-1	0050	Reinforcement - no section loss

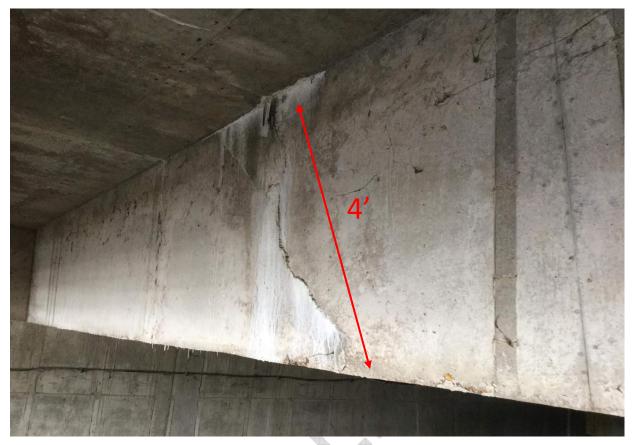
Element ID		Photo #	Notes
DB19-1	NY.	4080102	Wide crack not reducing structural capacity

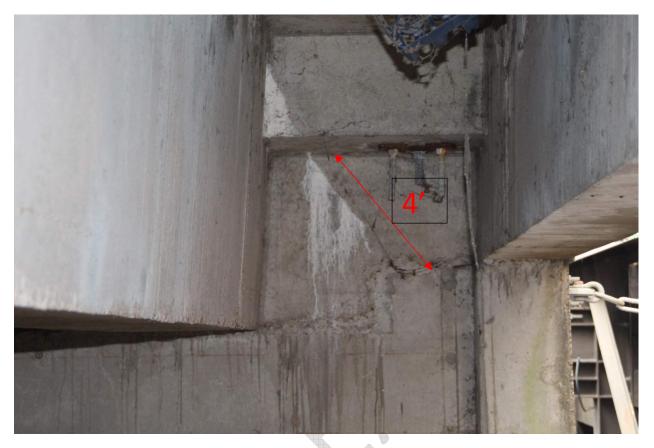
Element ID	Photo #	Notes
DB19-5	0236	Wide crack not reducing capacity and heavy leachate buildup

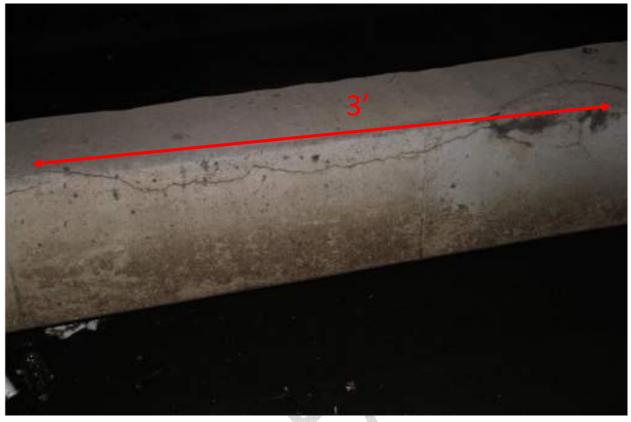
Element ID	Photo #	Notes
SW13-1	3722	Moderate width crack - 8 x more in element with similar leaching

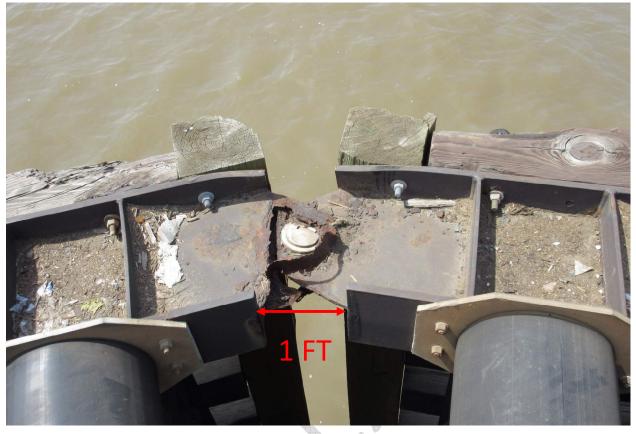
Element ID	Photo #	Notes
FF5-1	0038	Partial depth splitting on full length of two timbers

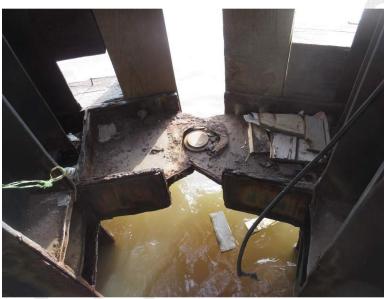
Figure 7. Failed pin connection at joint in secondary framing at Bent 26.

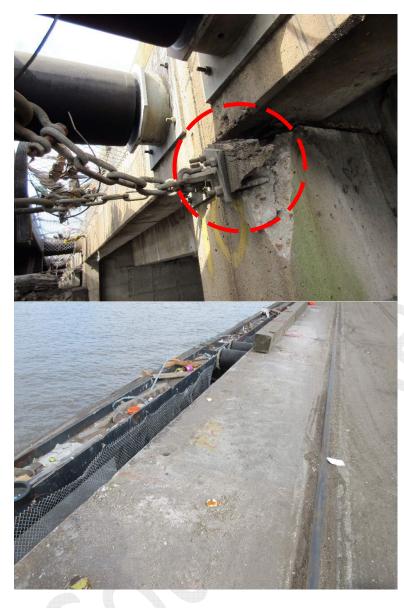
Figure 8. Failed stay chain anchorage at Bent 10 (red dashed circle).

Figure 9. Missing wharf log near Bent 18.

В	erthing Compo	nent Ratings and Element Summary
Component / Element(s)	Rating	Comments
Fender System		
 Rubber Fender 		Severely displaced or damaged FAUs (FA 1-1, FA 4-1, FA 10-1,
Absorption Unit		FA 11-1, FA 16-1, and FA 17-1). Figure 4 and Figure 5.
– TIM Facing		
 CS Secondary Framing 		Failed pin connections at joints in secondary framing at Bents 1, 10, 17 and 26. Figure 6 and Figure 7.
 – GS Stay Chains 		Missing or broken stay chains (CH 4-1, CH 8-1, CH 8-2, CH 12-1, CH 12-2, CH 15-1, and CH 15-2). Figure 8.
 CS Fender Piles 		Not accessible
Mooring System		
– MT Cleat

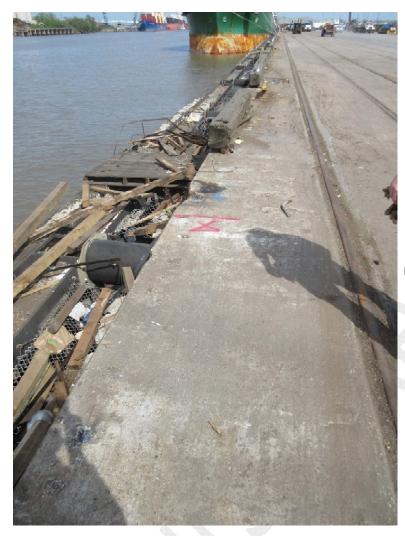
Figure 10. Missing wharf log near Bent 4.

35	
Ar	cillary Compon	ents Ratings and Element Summary
Component / Element(s)	Rating	Comments
Guards		
– TIM Wharf Logs		Missing wharf logs or damaged connections at WL 4-1, WL 7-2, WL 11-1, WL 12-1, WL 15-1, WL 17-1, and WL 19-2. Figure 9 - Figure 11
Crane and Train		
– MT Train Rails

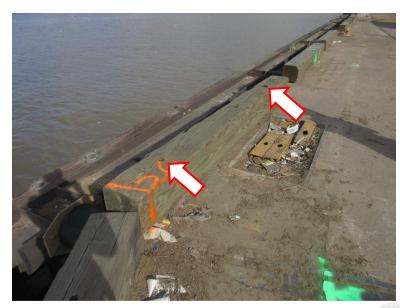
Figure 11. Wharf log with missing anchors near Bent 26 (arrows).
